OPERATIONAL ASSESSMENT
of
OPTEC NGN-2 NEPHELOMETERS

Prepared by
AIR RESOURCE SPECIALISTS, INC.
1901 Sharp Point Drive
Suite E
Fort Collins, Colorado 80525

July 1, 1994

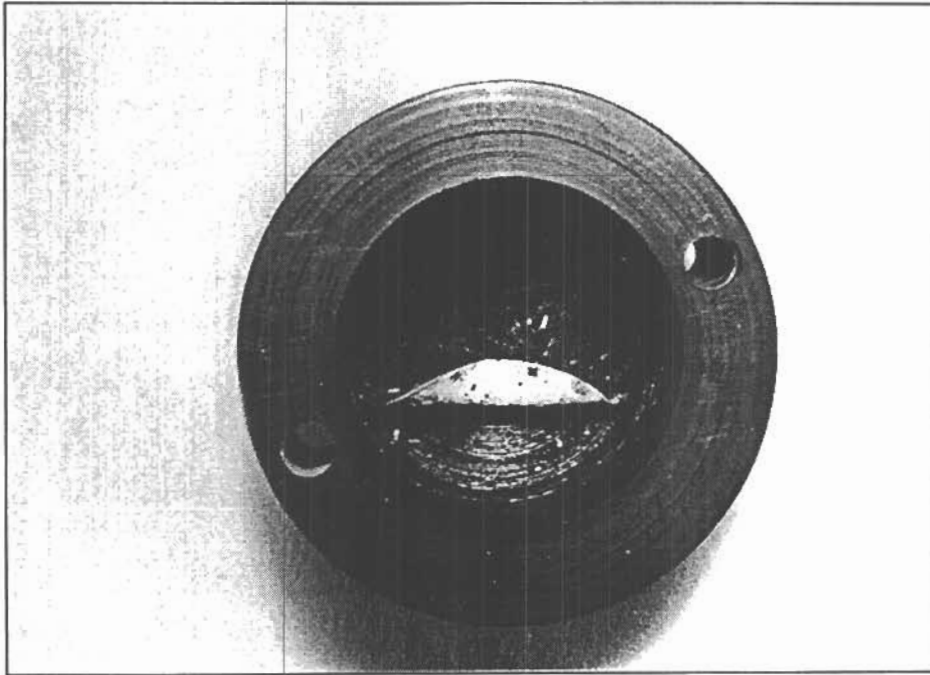
The design of the original light trap allows it to act as a water trap when the optical chamber becomes wet (Figure 2-1). The collected water reflects light directly into the scattered light detector causing extremely high and erratic zero, span, and ambient readings. Additionally, the flocking paper, glued to the base of the trap, separates from the metal surface after becoming saturated with water (Figure 2-2). ARS has designed, manufactured, and installed a new light trap at all operational sites, replacing the original traps. These traps have no glued parts and employ a wicked drain to quickly remove water from the trap (Figures 2-3, 2-4, and 2-5). Laboratory and field tests have proven the new light traps to be very effective in greatly reducing the adverse effects of water inside the optical chamber (Figures 2-6 and 2-7).

Figure 2-1.
Peeling Optical Surface
Due To Moisture
(Original Light Trap).

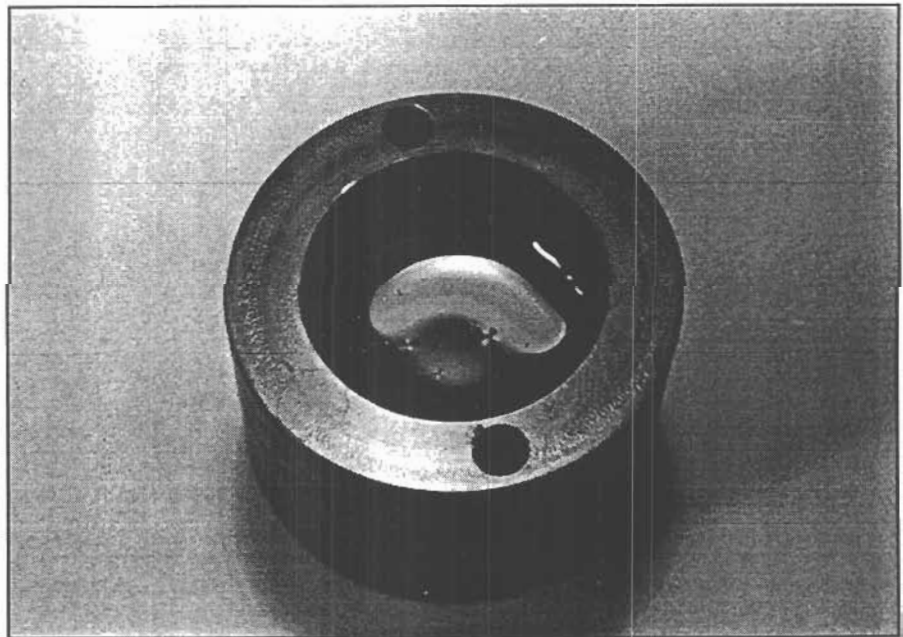
Figure 2-2.
Water-filled Light Trap.

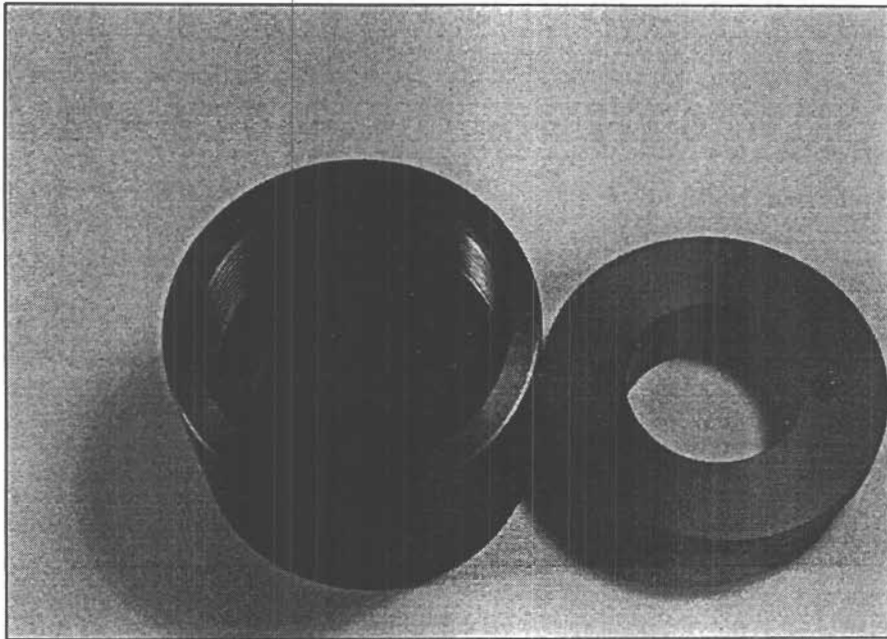
Figure 2-3.
ARS Cone Style Light
Trap With Threaded Base.

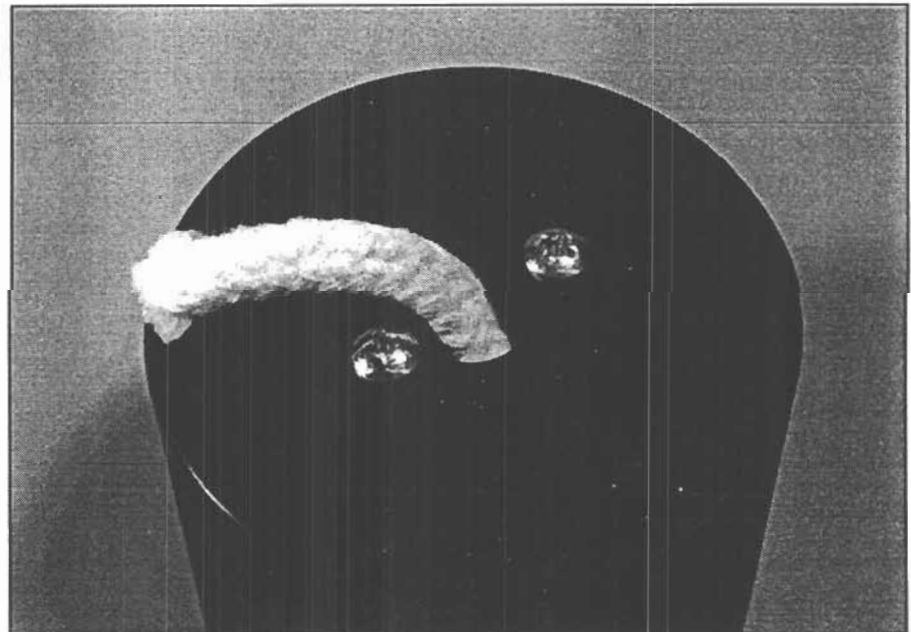
Figure 2-4.
Bottom Surface of ARS
Light Trap Showing
Cotton Wicking.

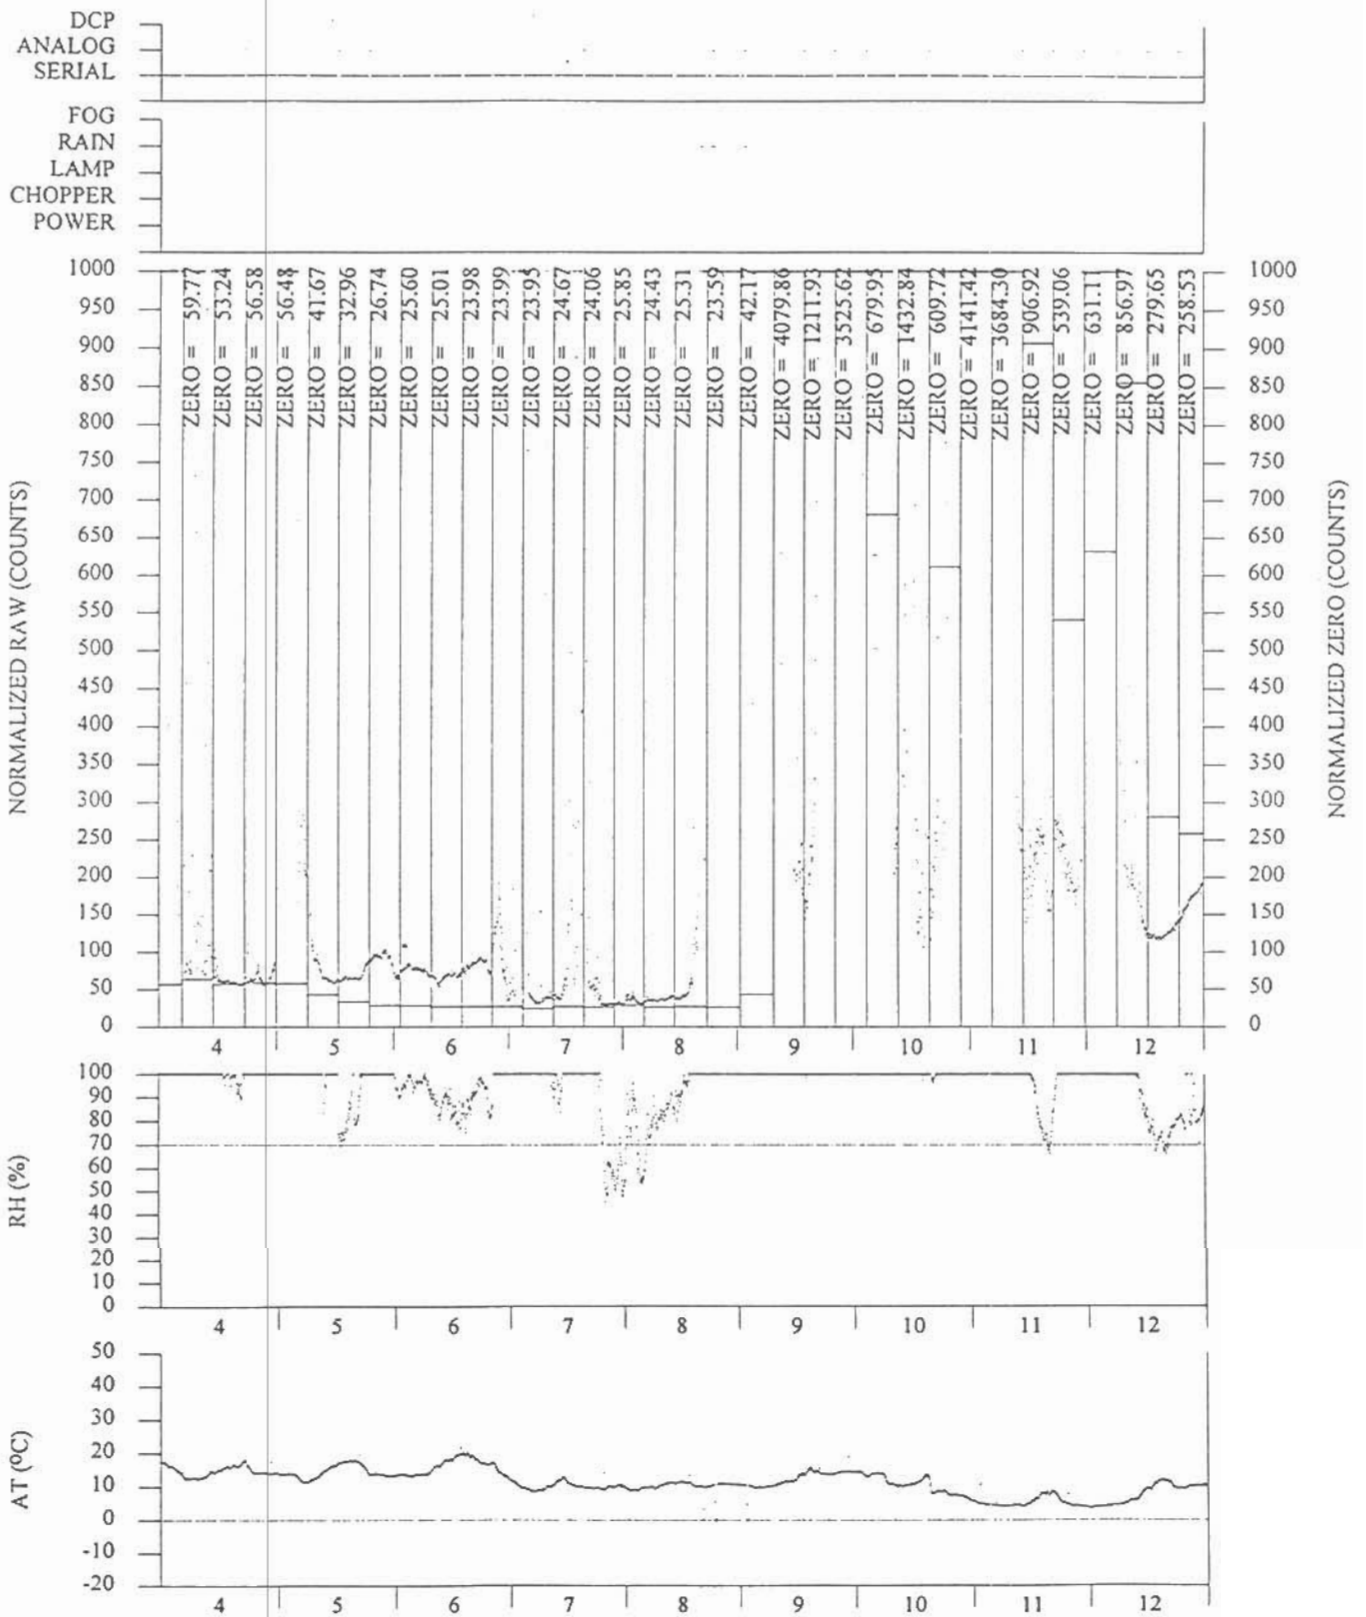
LYE BROOK WILDERNESS

Figure 2-6. Instrument Malfunction After Precipitation Event on September 8-9, 1993.

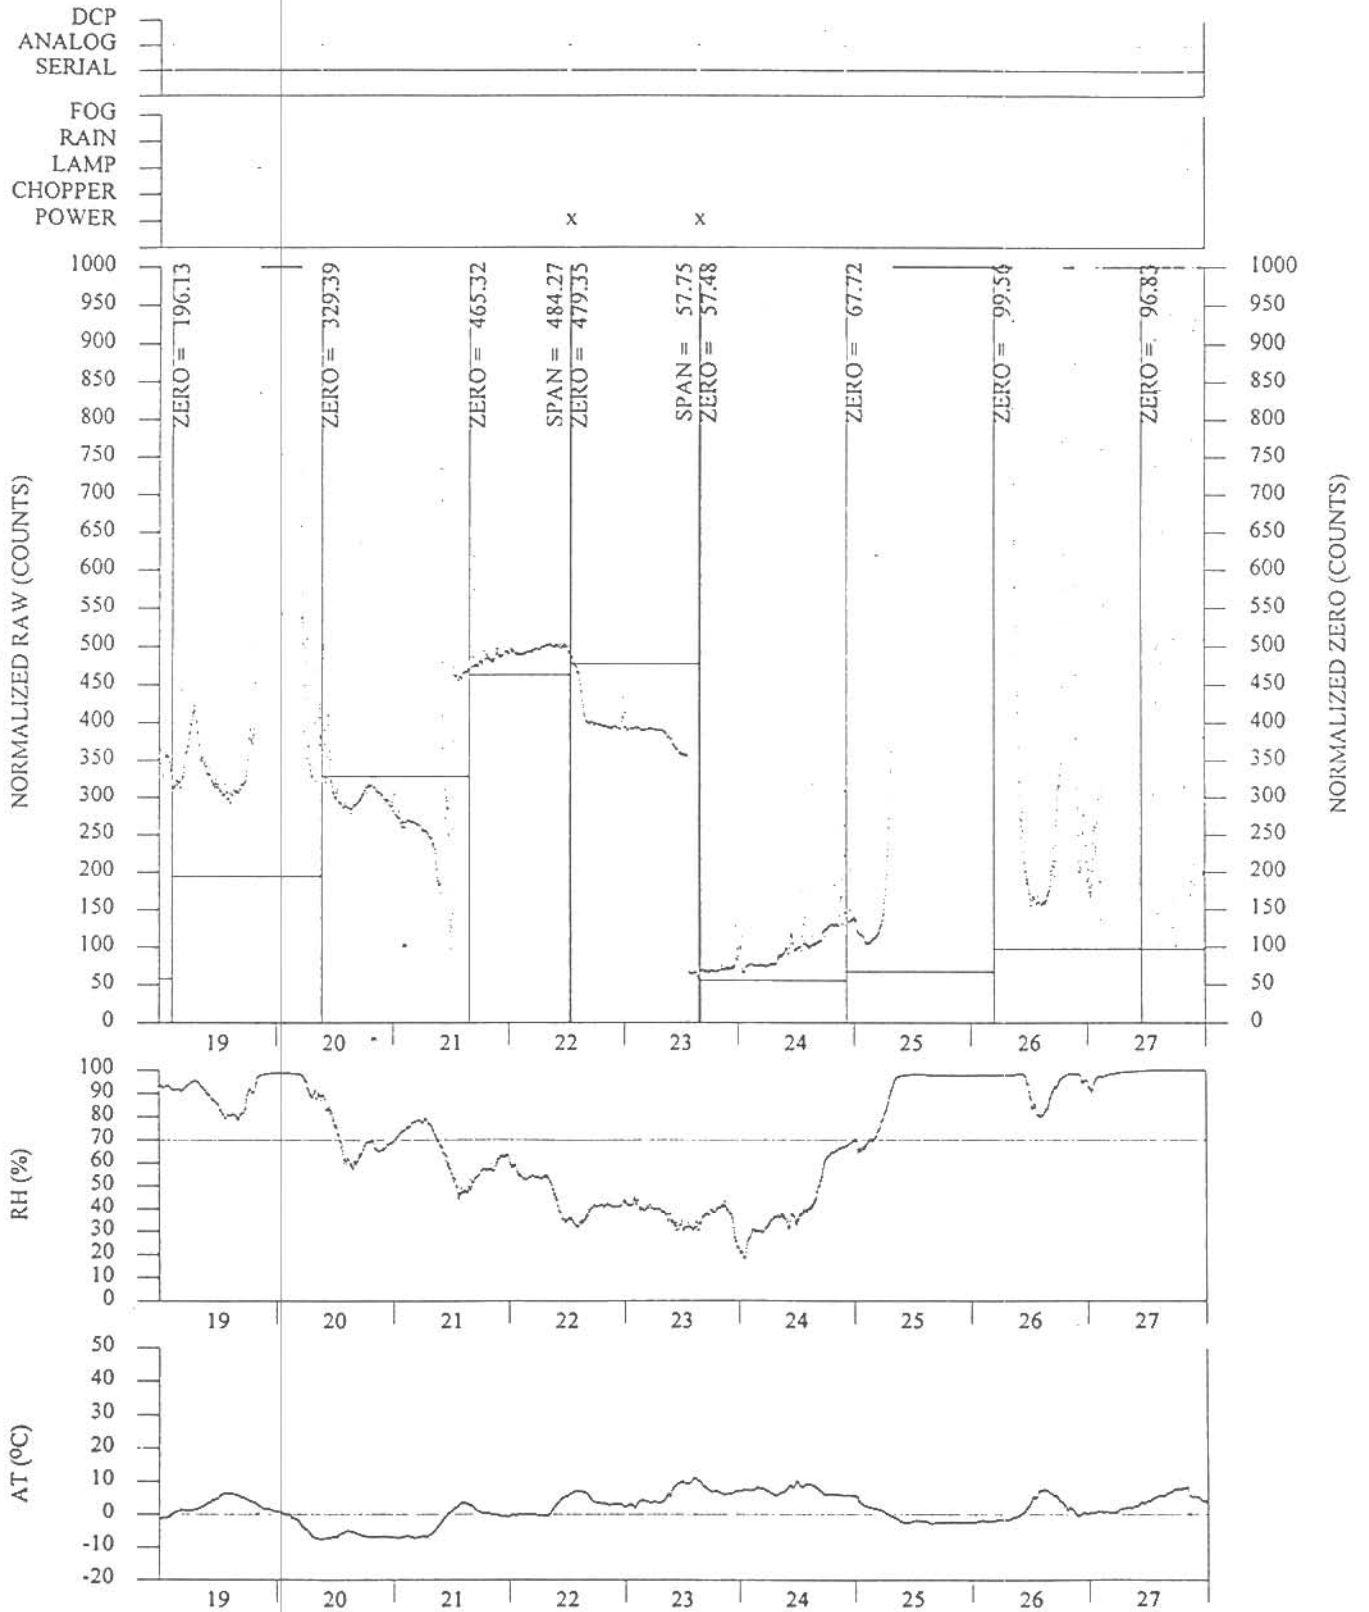
DOLLY SODS WILDERNESS
11/19 - 11/27/93

Figure 2-7. Improvement in Instrument Response After Installation of New ARS Light Trap on 11/23/93.

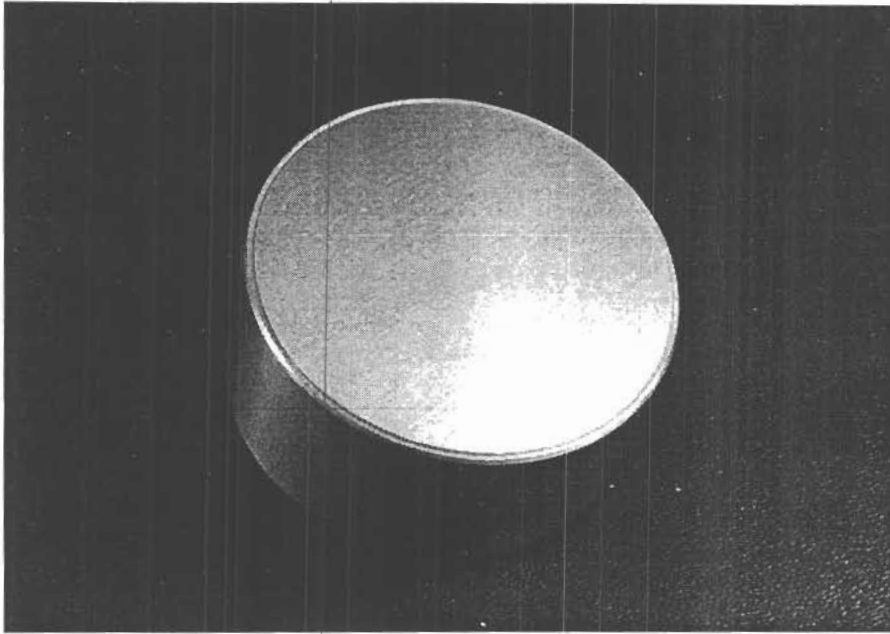
The original clean air filter system is highly susceptible to collecting and holding moisture in wet environments (Figure 2-8). Saturated filters greatly effect zero calibrations in the field. High humidity sites, such as Lye Brook and Acadia, have had unacceptable zero fluctuations due in part to these filters. Several filters, returned from the field and dismantled for evaluation, have been saturated with water and covered with mold (Figure 2-9). Additionally, the filter design requires that the entire filter assembly be returned to Optec for filter replacement at a cost of \$55 plus shipping. ARS modified of the filter holder to allow for easy field replacement of the filter element at a cost of approximately \$4 per element. The new filter canisters have been installed at all operational sites (Figures 2-10, 2-11, 2-12, and 2-13). On-site operators are now replacing the clean air filters at two week intervals just prior to performing a manual span calibration. The IMPROVE sites have been programmed to perform an automatic clean air calibration every six hours in order to monitor performance of the system. The new filter units appear to have minimized erratic zeros previously caused by filter contamination (Filter 2-14).

Figure 2-8.
Sealed Clean Air Filter
as Supplied by Optec.

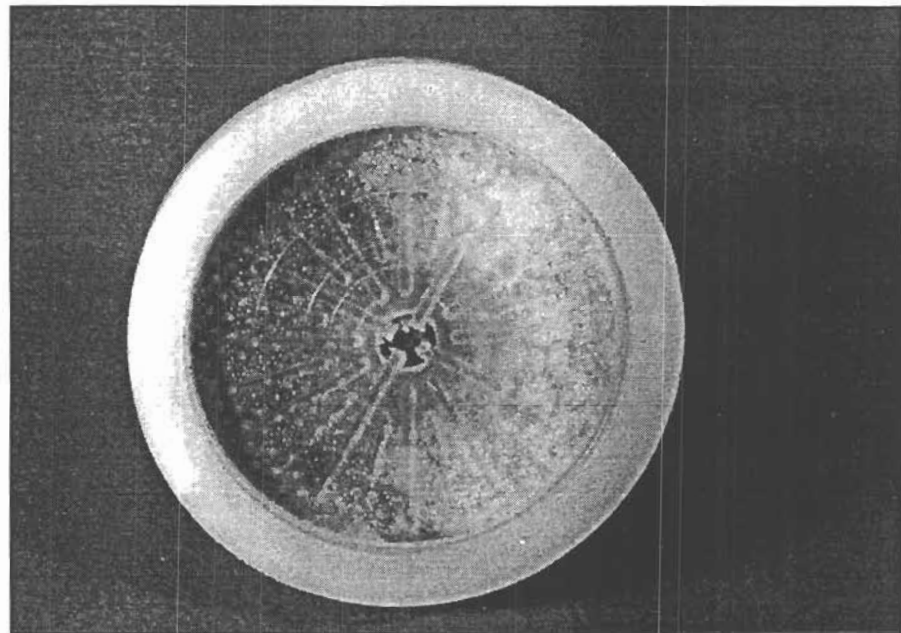
Figure 2-9.
Filter Element
Removed from Optec
Style Filter Showing
Growth of Mold on
Element Surface.

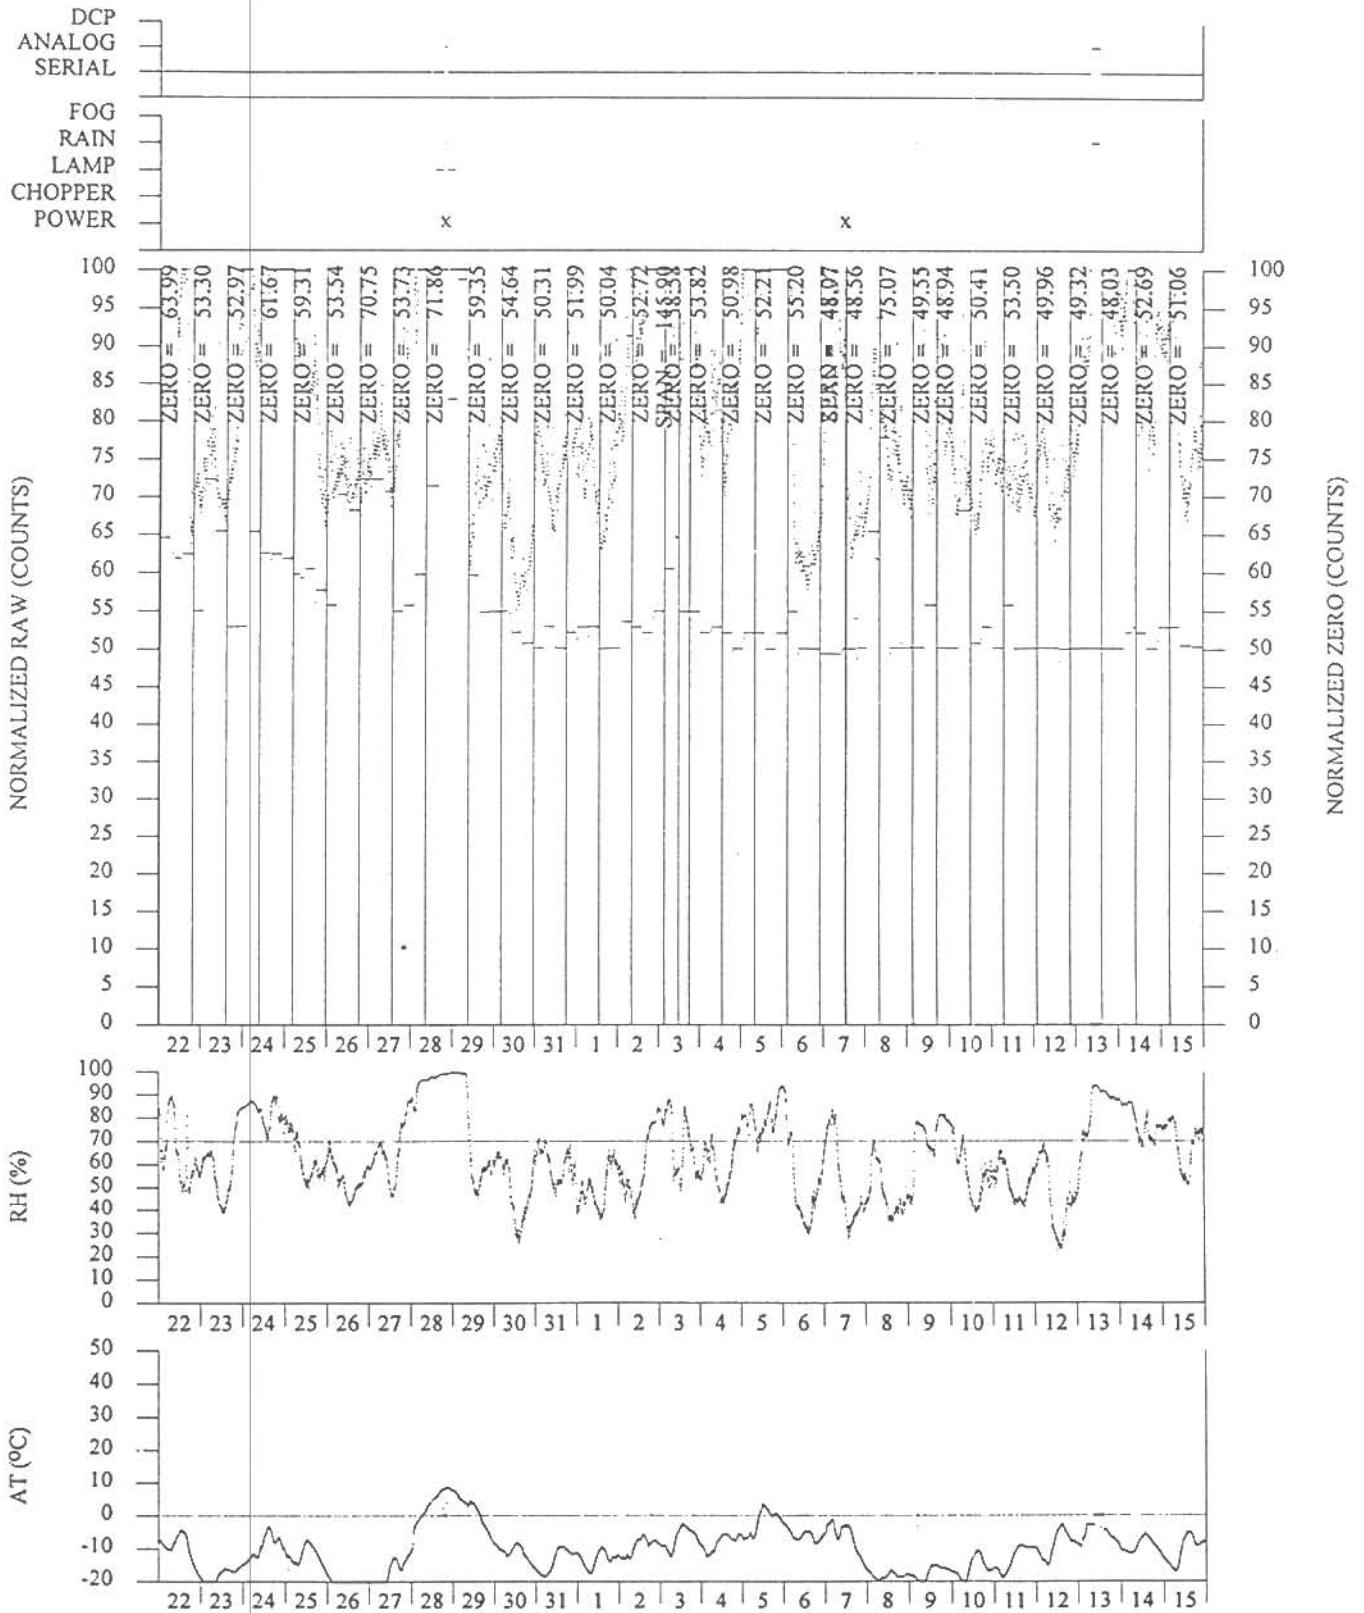
ACADIA NATIONAL PARK

Figure 2-14. Improvement in Instrument Response After Installation of New ARS Clean Air Filter on 2/3/94.

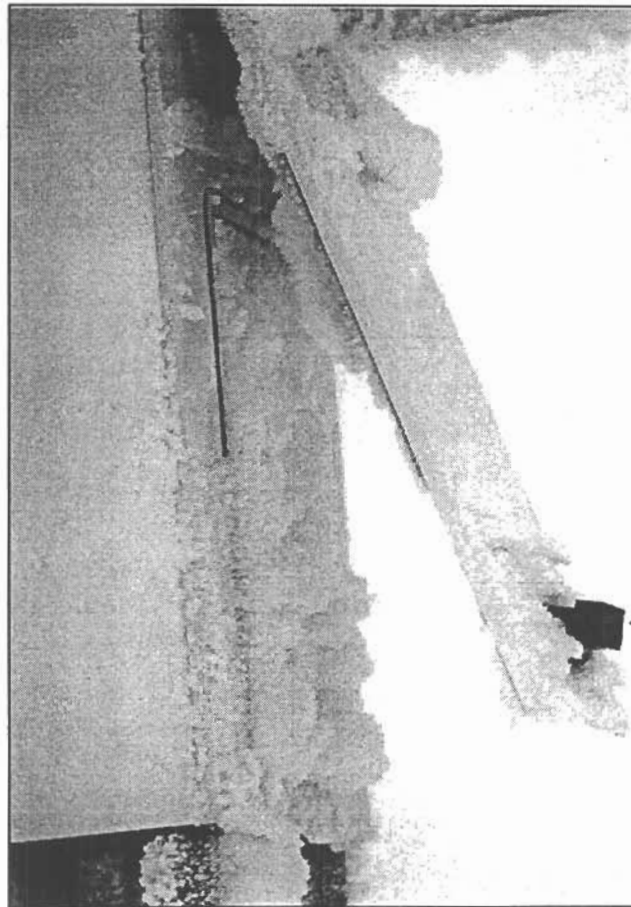
The original precipitation sensor proved ineffective in closing the instrument door quickly enough to keep moisture out of the optical chamber. Optec supplied retrofit kits to increase the sensitivity of the precipitation sensor. ARS has installed these kits in all available instruments. Though more sensitive, the sensor still misses many precipitation events and is practically ineffective in sensing snow; therefore, this change has not solved the problem of precipitation entering the optical chamber. ARS is now investigating two possible alternatives:

Figure 2-15.
Optec Precipitation
Sensor.

1. An independent wetness sensor to close the nephelometer door during precipitation events; and
2. A rain/snow shield retrofit that can be installed over the door to shed these elements.

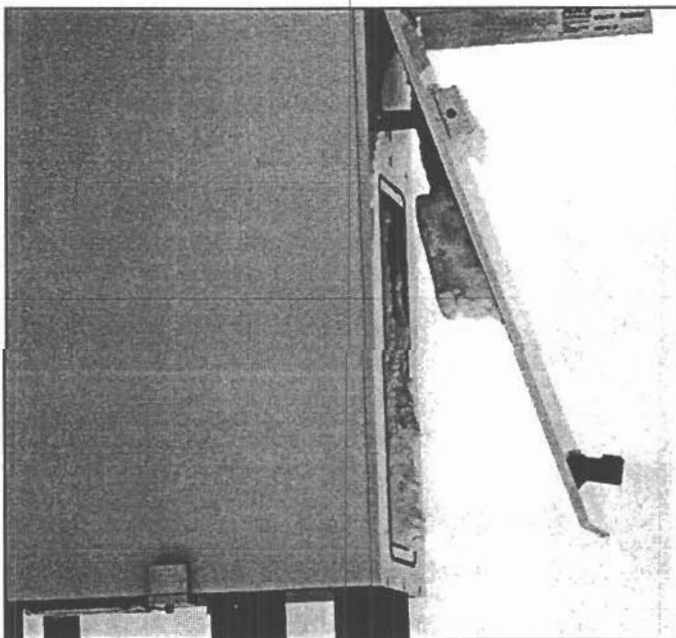
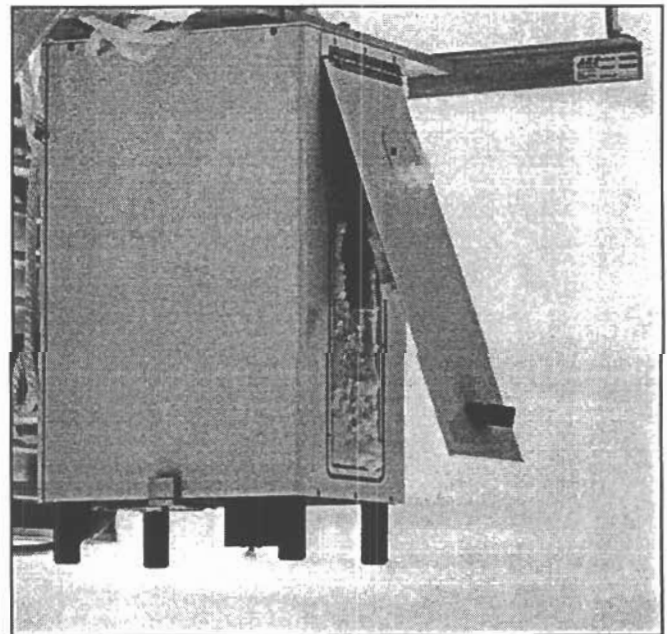
Figures 2-16 and 2-17.

Occasionally the optical chamber door fails to seal properly. Insects and debris that become lodged between the door and the nephelometer case can usually be removed by the site operator. Ice and snow, too, have been observed to accumulate under the door seal and impede proper door closure. These door closure problems are inherent in this design of nephelometer; however, the weather related issues could be minimized with the installation of a more effective precipitation sensor or a rain/snow shield as mentioned above.

Figures 2-15 through 2-17 show snow and ice buildup on the Mount Zirkel instrument. The Optec precipitation sensor did not close the door correctly and allowed precipitation to collect on the inlet screen and door seals as well as inside the optical chamber.

Snow and Ice Build-up on the NGN-2 Nephelometer at Mount Zirkel Wilderness. (Note that the Optec heated precipitation sensor is free of snow yet does not provide proper protection from the elements.)

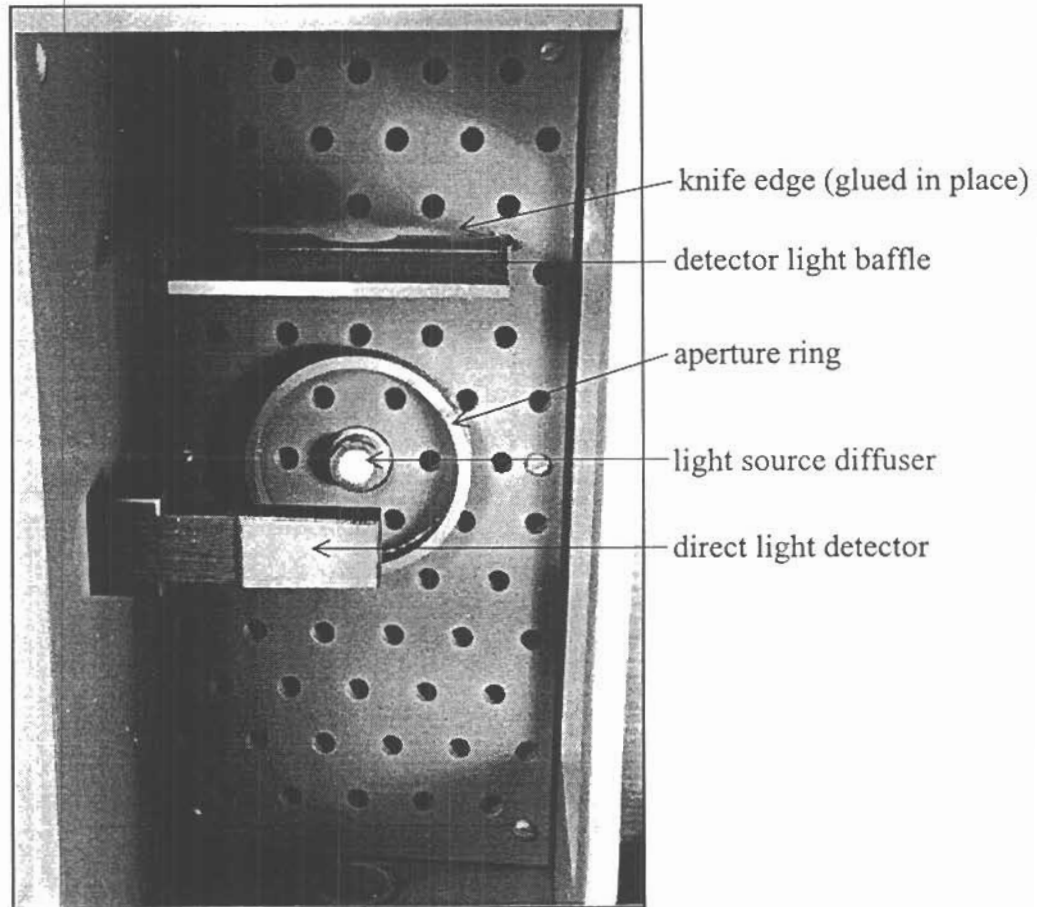
A number of instruments have had the black paint on the light baffle peel off after instrument installation in the field. This caused the zero, span, and ambient readings to become extremely erratic. ARS pulled the instruments from the field, located the problem, and shipped the equipment to Optec for evaluation. Optec repaired these instruments under warranty. Optec has varied their light baffle manufacturing and painting procedures over time but has not solved all of the problems. The last six (6) nephelometers received from Optec had paint peeling from the aperture rings. ARS is continuing to work closely with Optec to resolve this issue. Figures 2-18, 2-19 and 2-20 depict this issue.

Figure 2-18. Inside View of NGN-2 Optical Chamber.

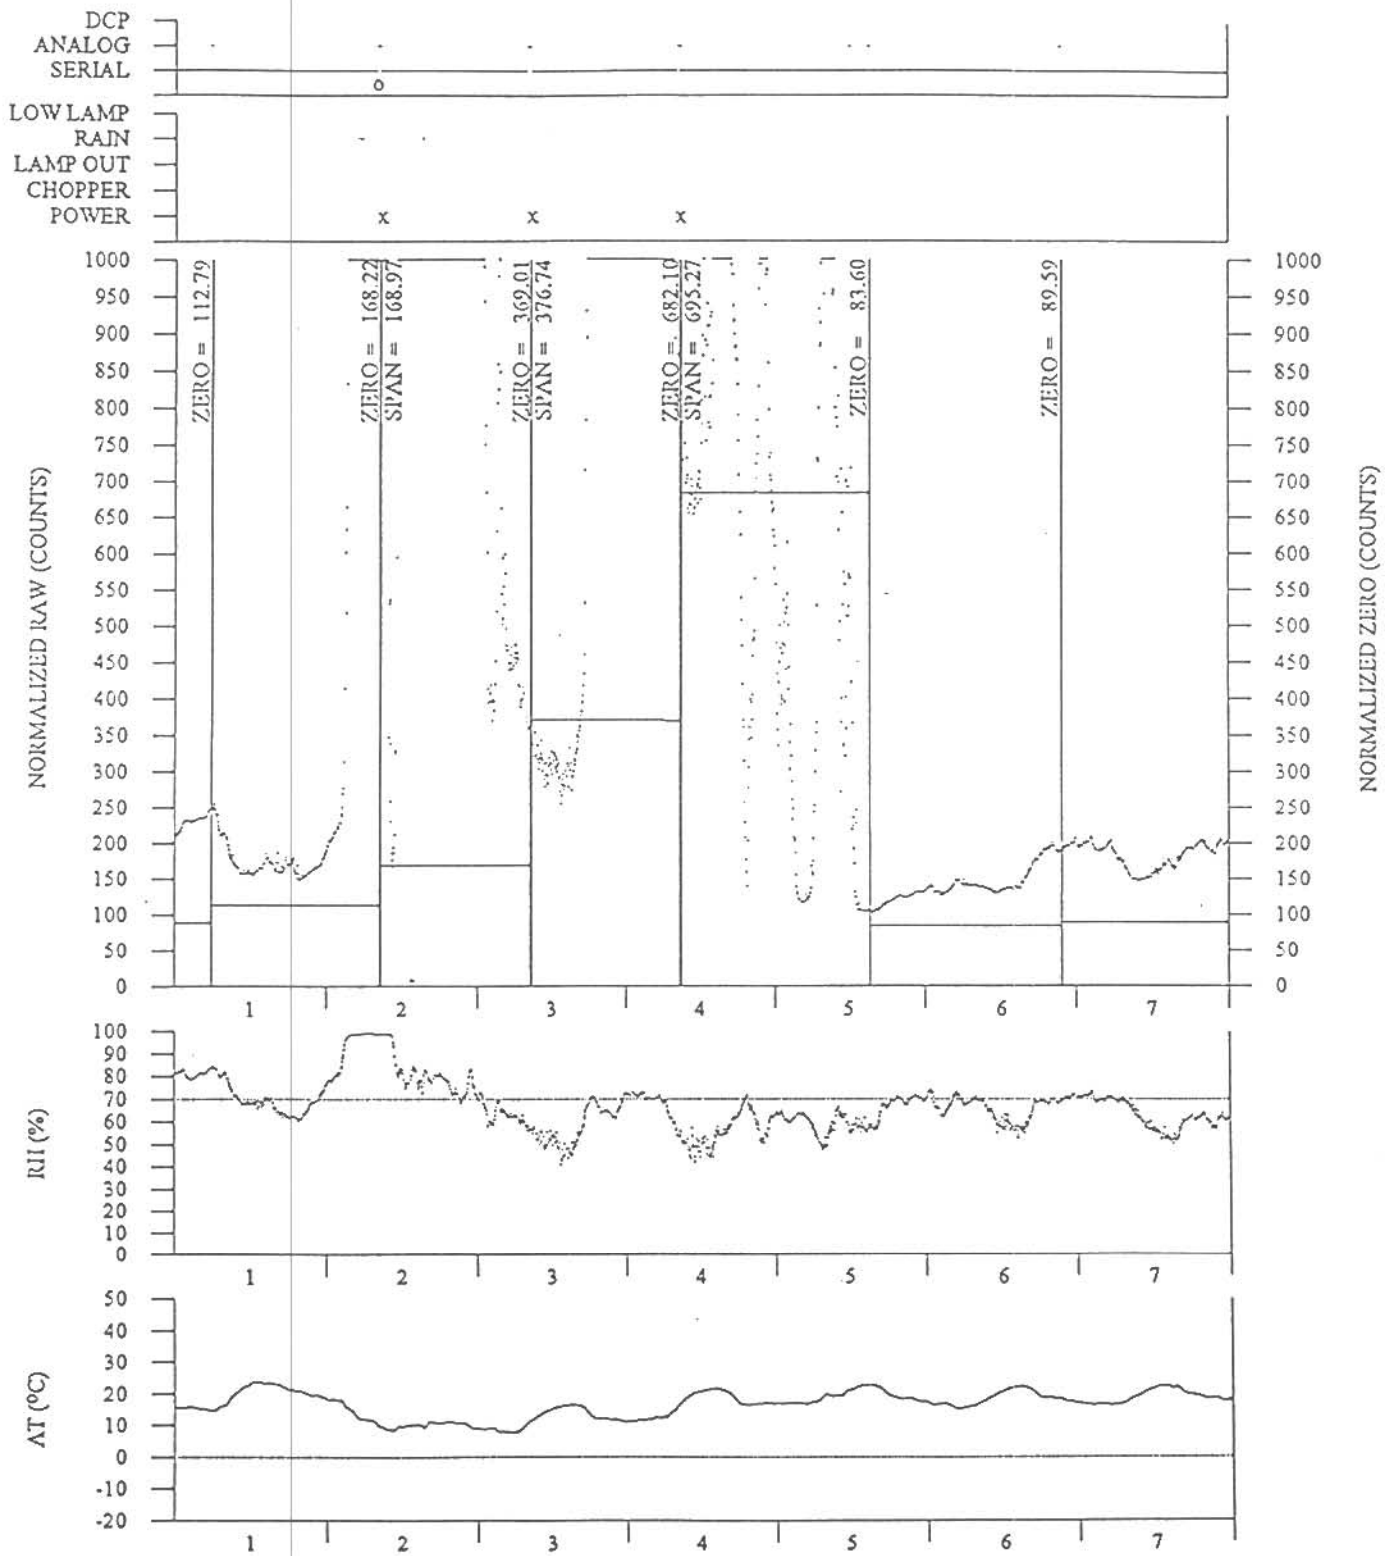
UPPER BUFFALO WILDERNESS

Figure 2-19. Effect of Peeling Paint on Upper Buffalo Instrument.

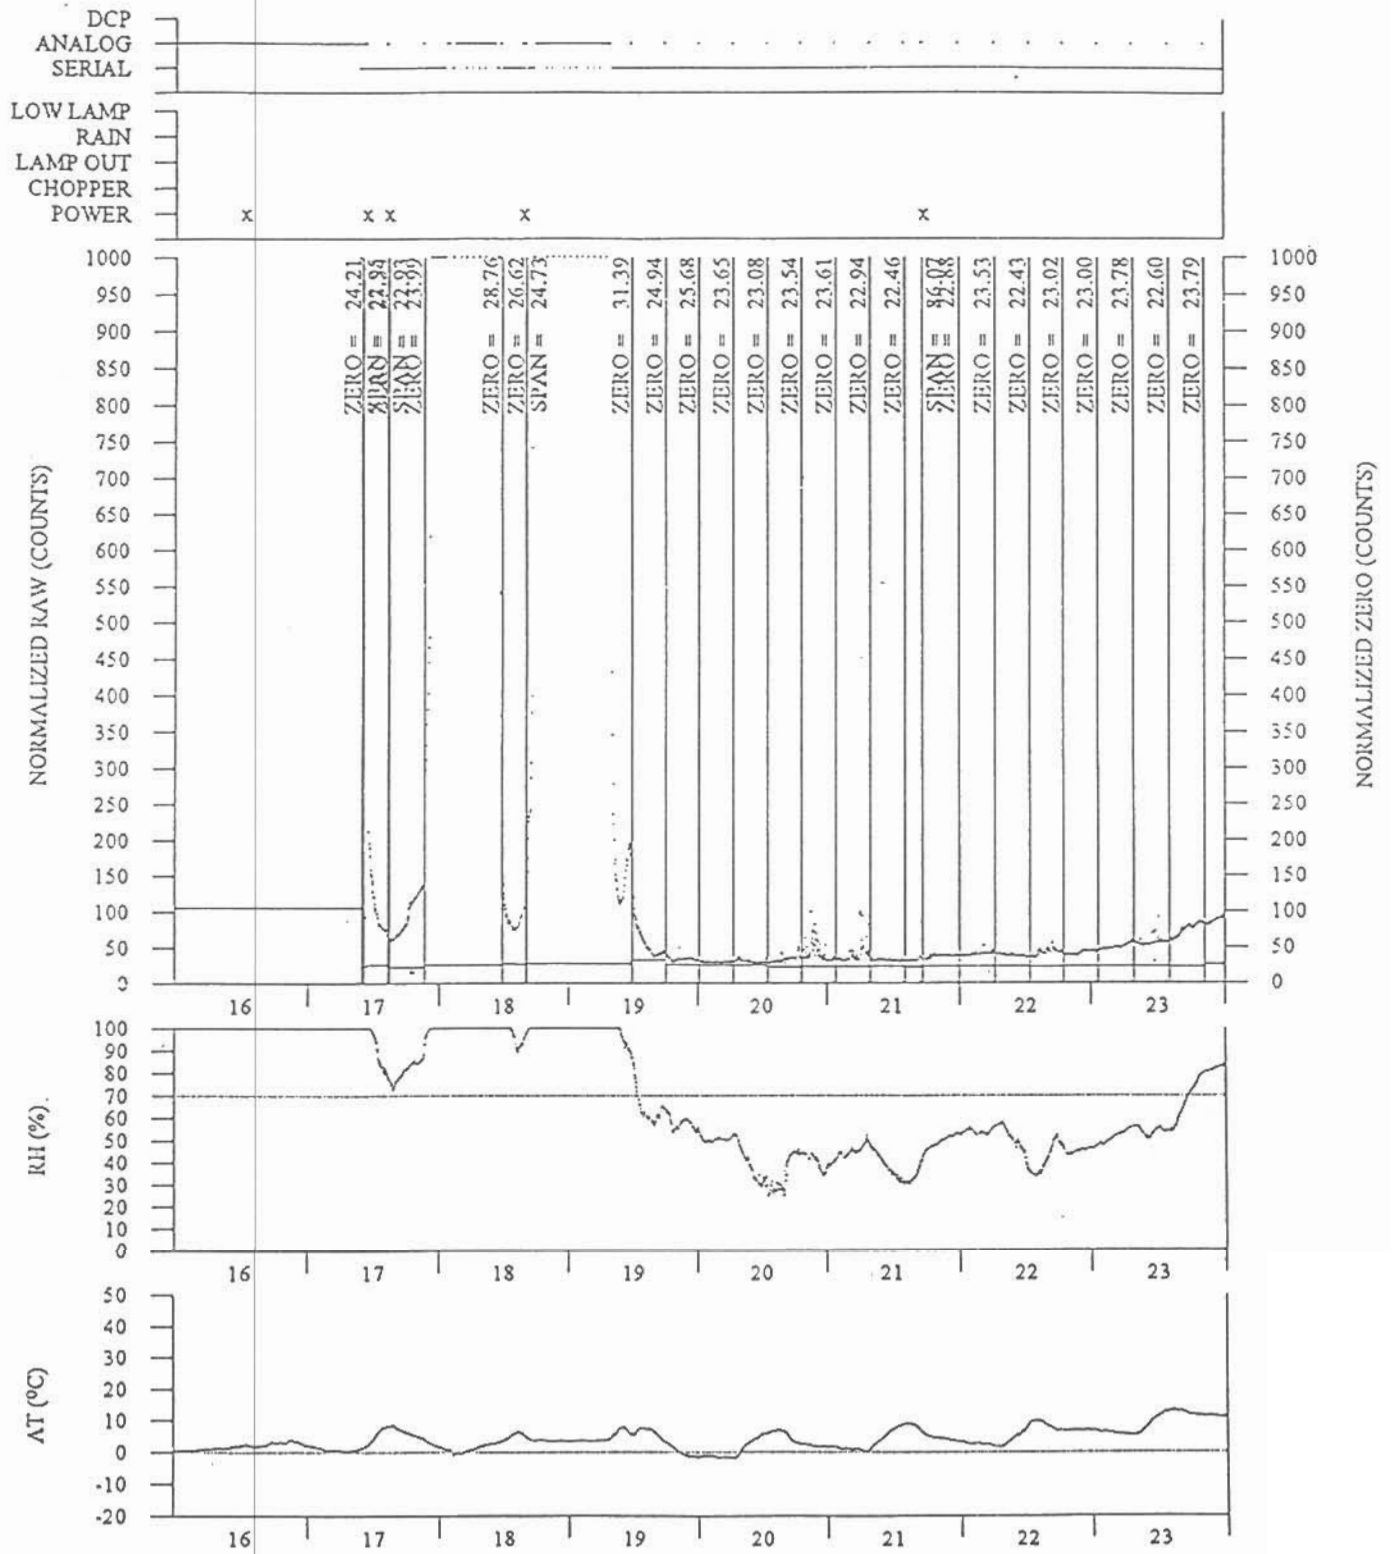
UPPER BUFFALO WILDERNESS

Figure 2-20. Improved Instrument Response After Repair of Peeling Paint. Re-installation on 11/17/93.

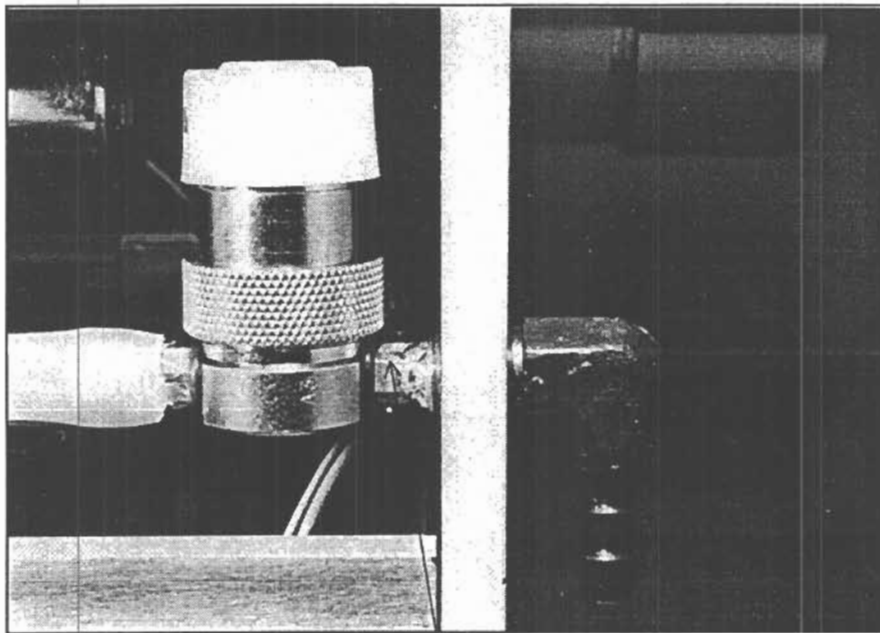
NGN-2 span gas valve

The original span gas valve is mounted in the instrument using Loc-Tite to glue a 10-32 threaded fitting into a 1/4" female elbow (Figure 2-21). This joint not only provides a pneumatic seal but acts as the sole mechanical support for the valve. ARS is currently soldering this joint after a failure occurs. Proper fittings are being ordered by ARS for replacement of the glued joints. The factory valve has failed on two occasions and may not

be suitable for long term field use or for automatic span calibrations. A more standard type valve has been ordered by ARS for evaluation as a replacement. It is strongly recommended that *no glue joints* be used in any field instrument.

Figure 2-21. NGN-2 Span Gas Valve, Non-standard Fitting that is Glued Together at the Factory. This Joint has been Soldered by ARS After Joint Failure.

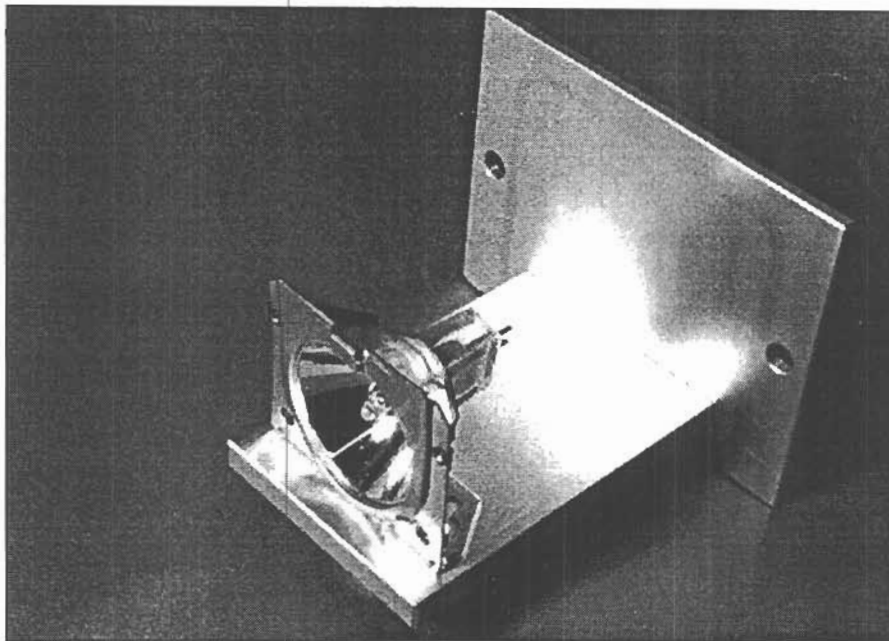
The NGN-2 light source bulb holder (Figure 2-22) is cumbersome and allows the operator to install a new bulb in an improper orientation. Even experienced operators have installed bulbs improperly due to the design of the holder (Figures 2-23 and 2-24). An improperly installed lamp can cause low chamber illumination, which in turn causes erratic zeros and readings. An operator logging only analog readings will not be able to detect this problem.

Figure 2-22.
Overall View of Bulb
Holder.

Due to problems associated with the original factory installed lamp tray system, ARS has developed and is implementing design modifications to correct the inadequacies. An external wiring configuration for the lamp is now being used which will alleviate the wire chafing and lamp holder bending, major problems with the original design (Figures 2-25 and 2-26). In addition to preventing damage to the system, the new design makes it much easier for an operator to replace a lamp. The entire lamp tray can now be removed (Figure 2-27) from the instrument, allowing the operator to replace the lamp while on the ground and in a sheltered environment if desired. Misalignment of the lamp due to improper installation will be greatly reduced by the removable lamp tray. In addition lamp tray mounting nuts are now secured directly to the tray.

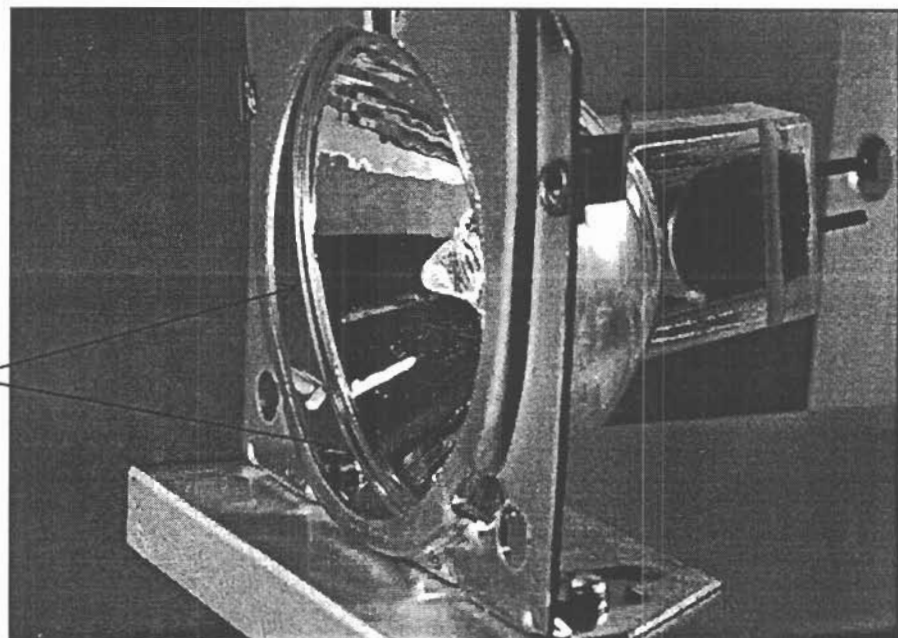
Figure 2-23.
Incorrect Bulb Installation.

Bulb seperated
from holder

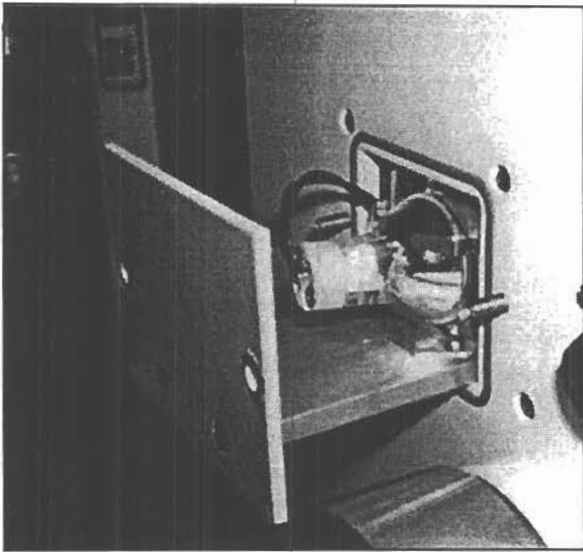
Figure 2-25.
Original Factory Lamp Tray System. Lamp
Wire Can Become Caught between Tray and
Nephelometer Opening.

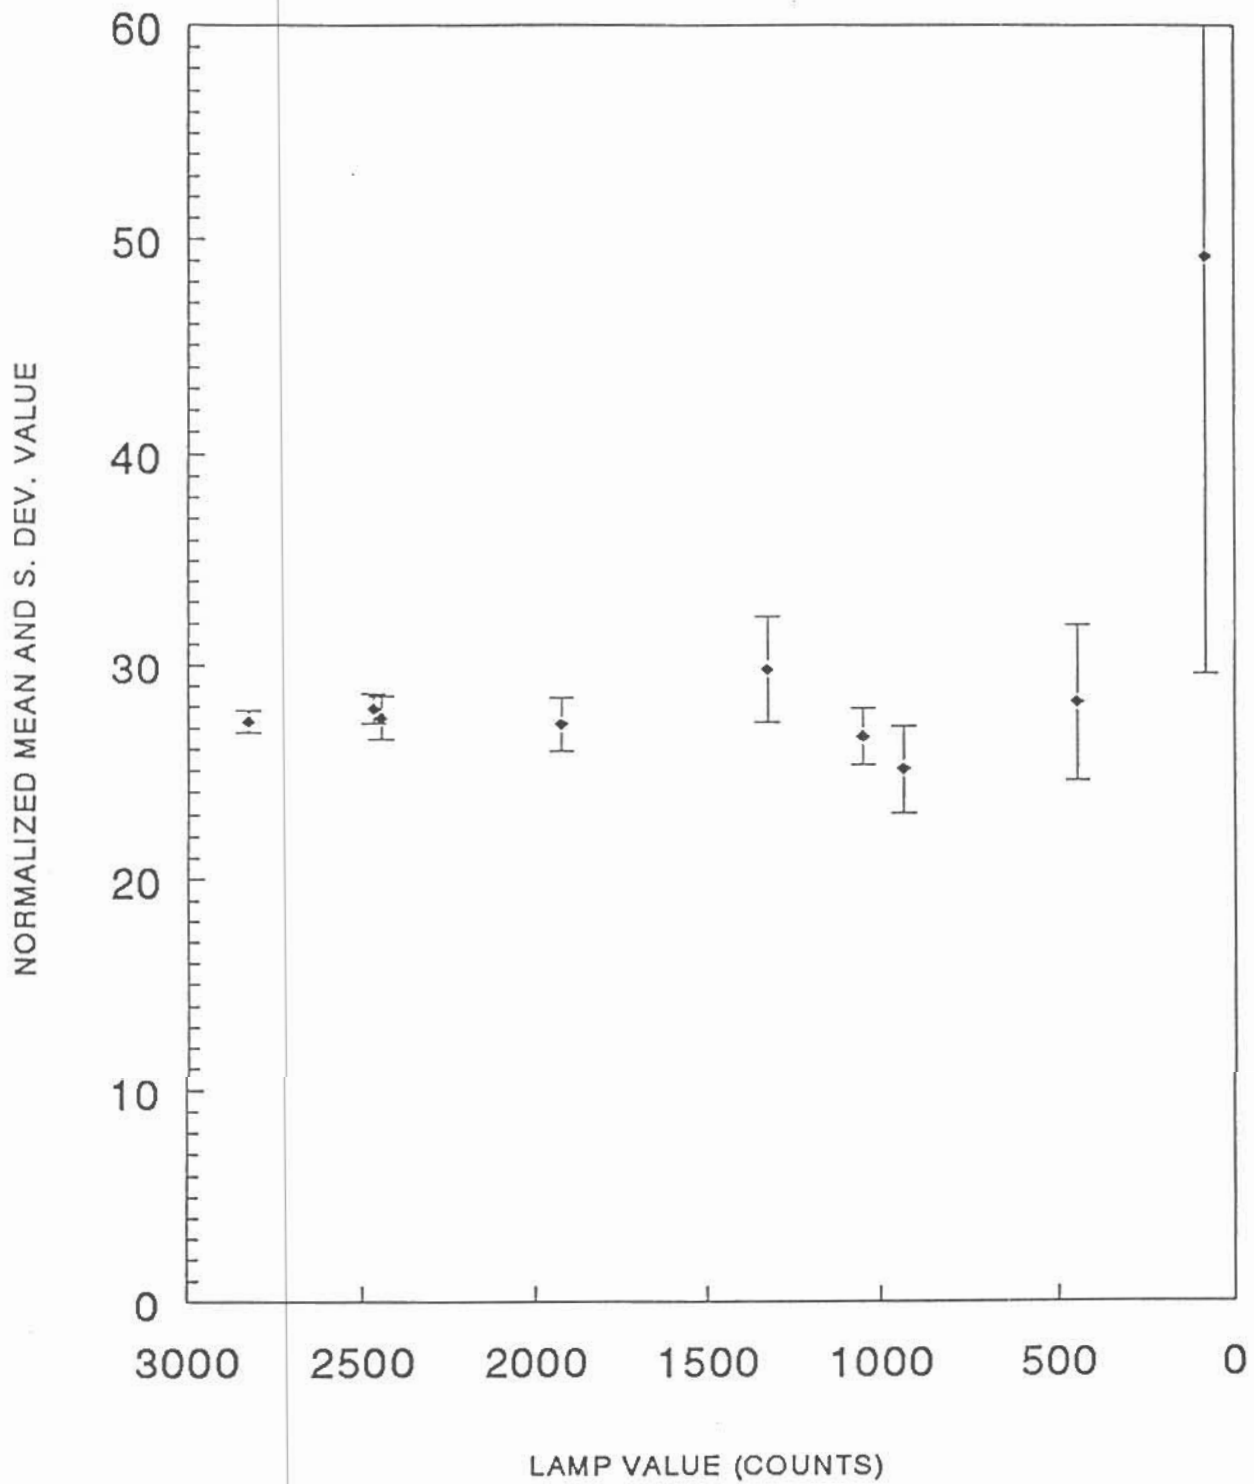
Figure 2-29. Variable of Zero Value, A Function of Lamp Value.
