IMPROVE Sampler Technical System Audits

Overview of 2017 audits

1/12/2018
CIRA
Derek Day

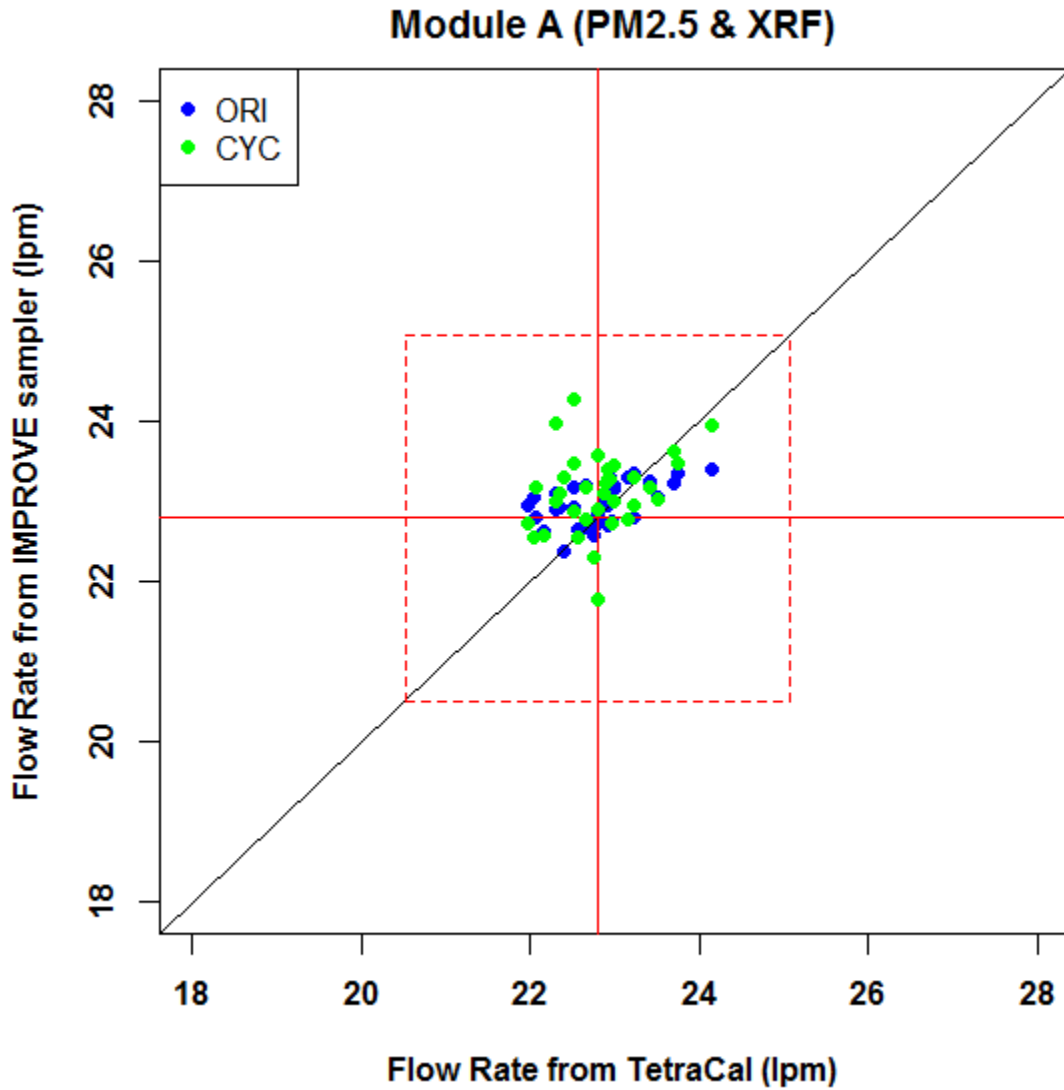
Figure 2. Flow rate comparison for Module A audits in 2017.

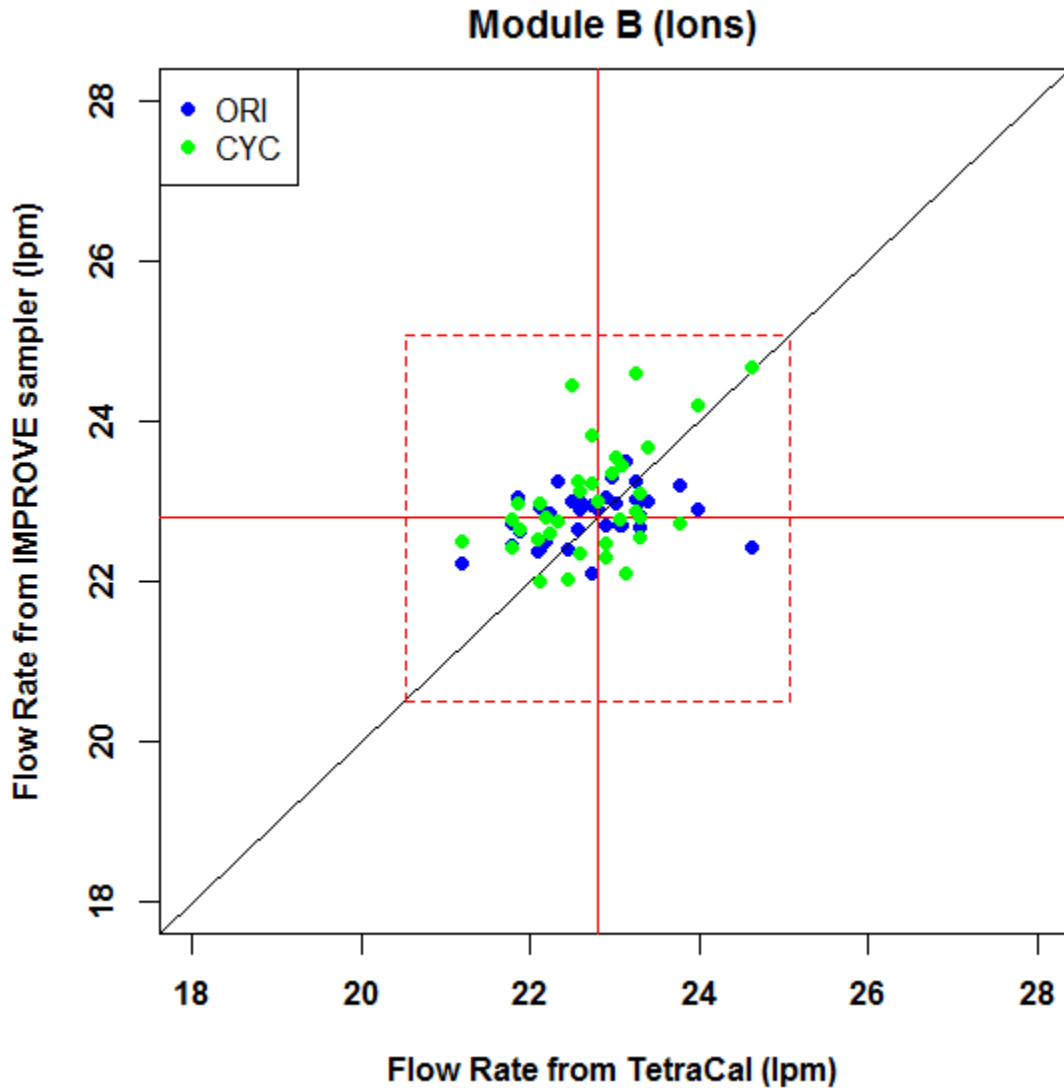
Figure 3. Flow rate comparisons for Module B audits in 2017.

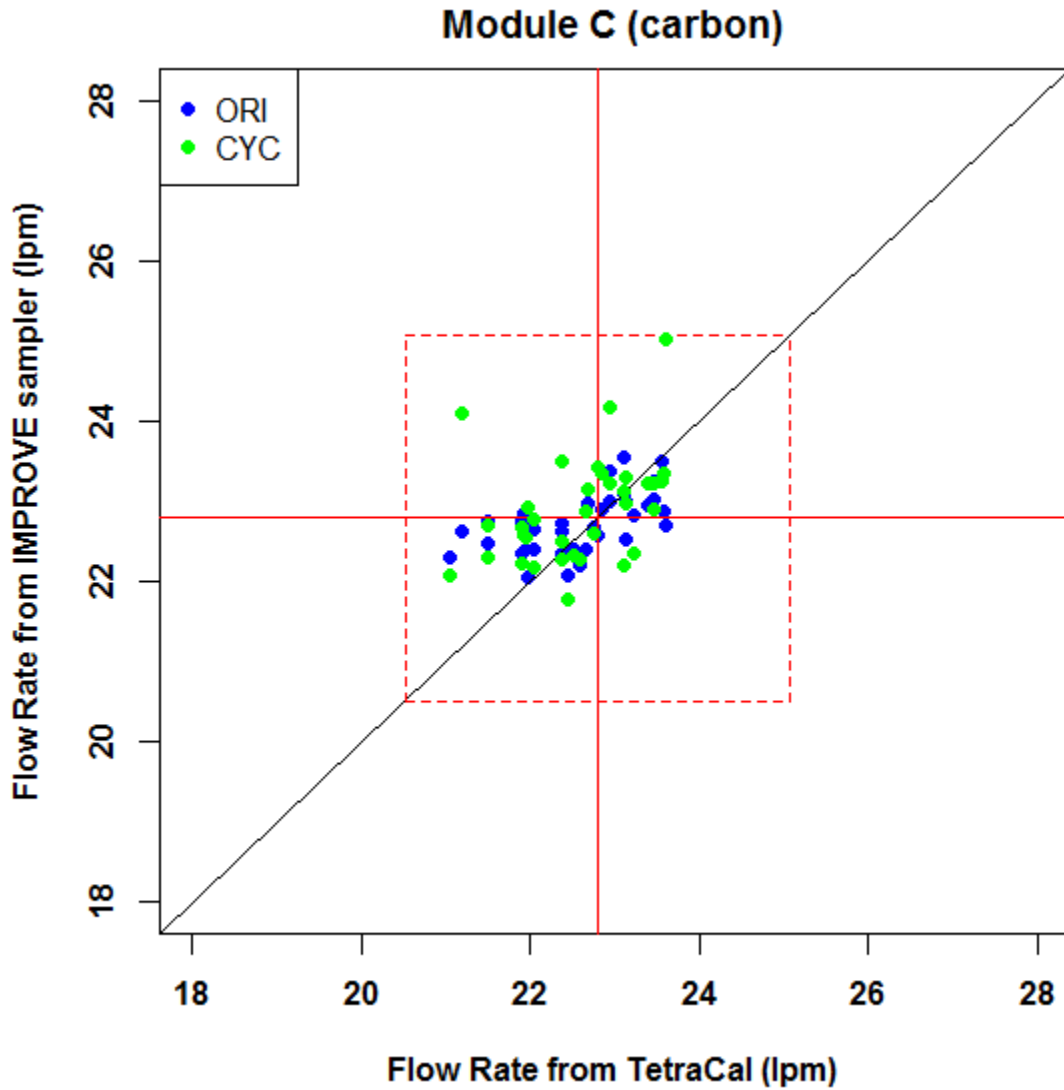
traceable reference standard. For the audits conducted by CIRA the flow rates were measured using a tetraCal flow meter which had been calibrated and certified by Mesa Labs. The audit devices undergo certification annually. Samplers fail the flow rate audit if either the flows differ from the nominal flow rate by more than 10% or if the sampler flow rate differs from the audit device flow rate by more than 10%. Results of audit flow rate checks are shown in Tables 1-4 and Figures 2-5. These figures show the nominal flow rate (solid red lines), the allowed deviation from nominal flow rate (dashed red lines), and a 1:1 line between the audit device and the IMPROVE sampler flow rates. Only one module (C module, Meadview) failed the flow rate criteria in 2017.

Figure 4. Flow rate comparisons for Module C audits in 2017.

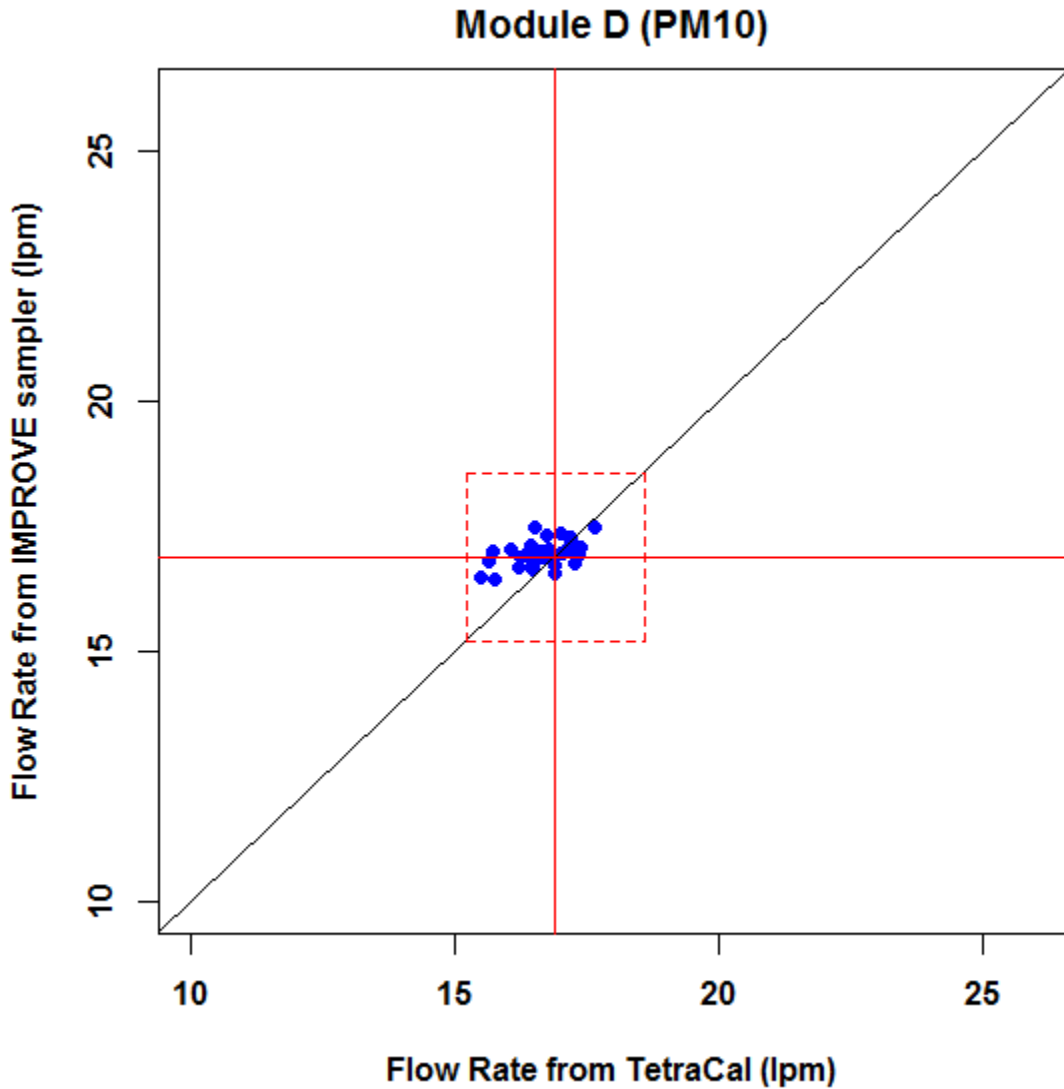
Figure 5. Flow rate comparisons for Module D audits in 2017.
